OLD CROW HOUSING CONDITION ASSESSMENT 2019

Provides a complete condition assessment for Vuntut Gwitchin Government and managed housing stock in Old Crow, Yukon.

Dennis Shewfelt, BA, MA
Shewfelt Planning & Consulting

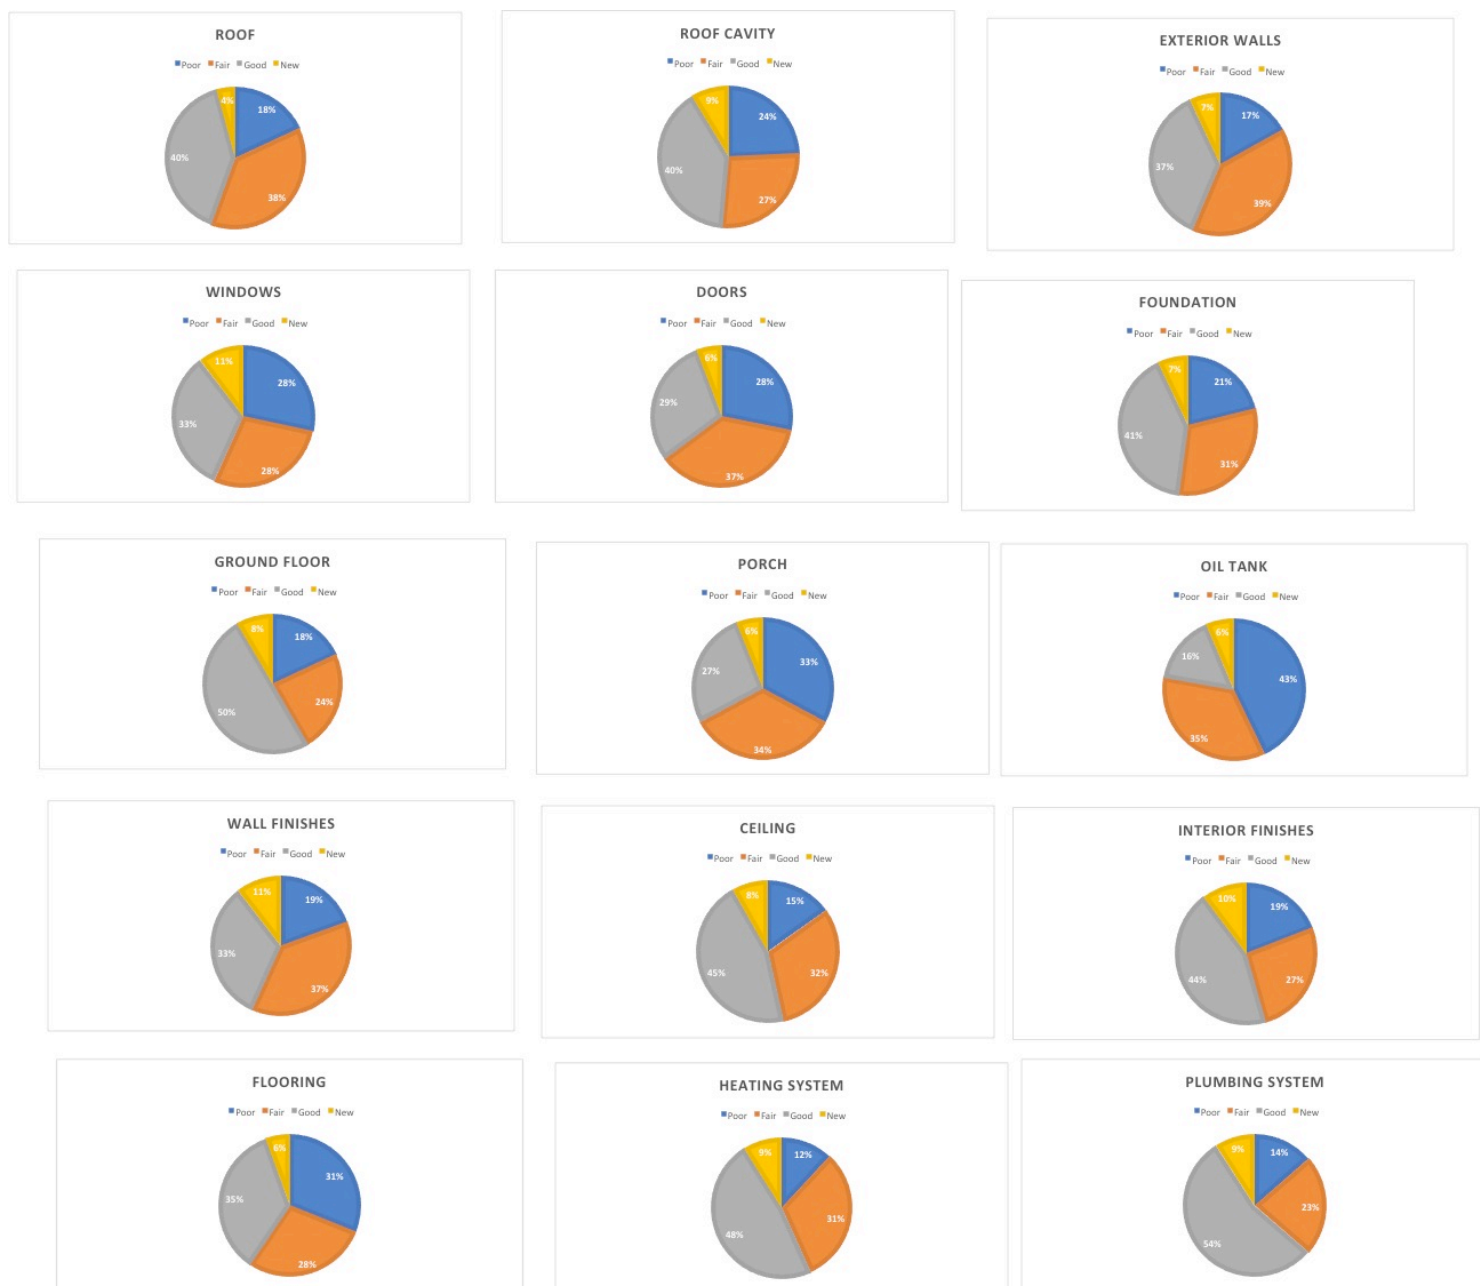
Appendix B: Condition Assessment Graph by Housing Component

Component Element:	Combined Poor & Fair Rating:	# of Houses:
Roof	56 %	68
Roof Cavity	51 %	62
Exterior Walls	56 %	68
Windows	56 %	68
Doors	65 %	79
Foundation	52 %	63
Ground Floor	42 %	51
Porch	67%	81
Oil Tank	78 %	94
Ceiling	47 %	57
Interior Finish	46 %	56
Flooring	59 %	71
Heating System	43 %	52
Plumbing System	37 %	45
